**LOCAL ROADS
CONNECTIVITY PROJECT**

Reconstruction of a Local Road in the Village of Moroishta – Municipality of Struga

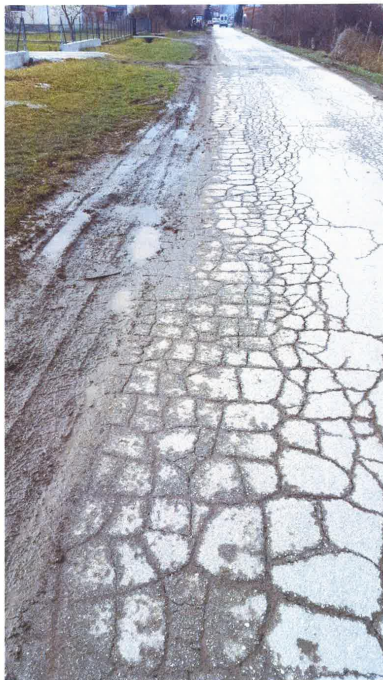
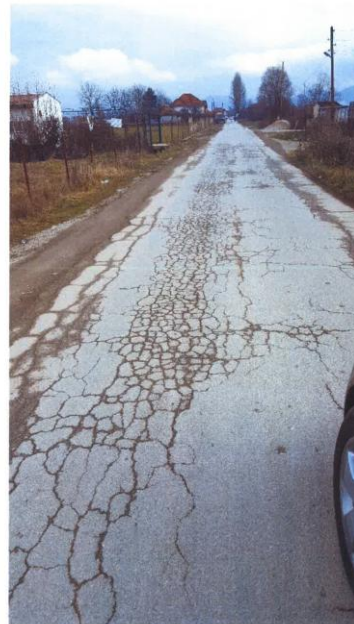
1. Images of the Road Condition Before Construction Work Began

- Severe surface deterioration (potholes, cracks, uneven pavement)
- Lack of proper drainage (standing water, erosion damage)
- Missing or damaged pedestrian pathways
- Poor or absent road markings and signage
- General disrepair affecting traffic safety

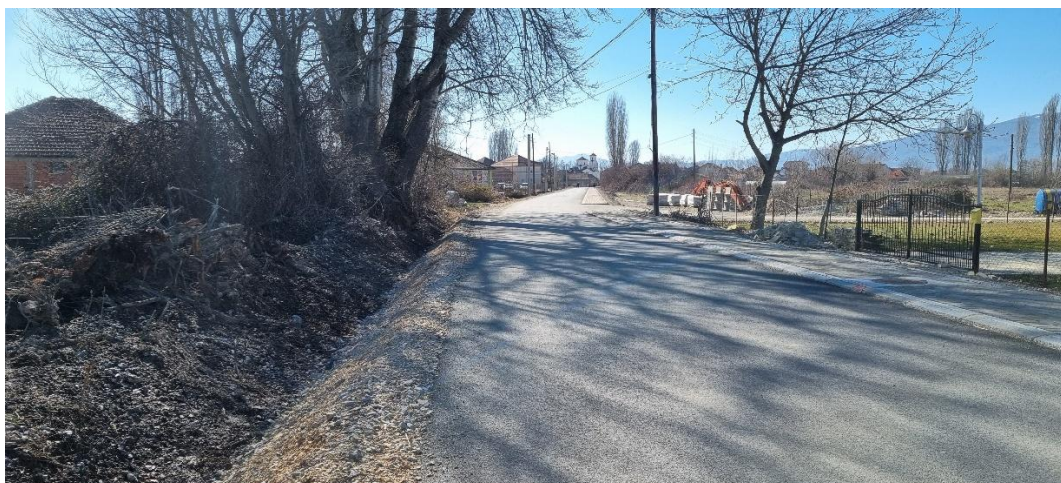
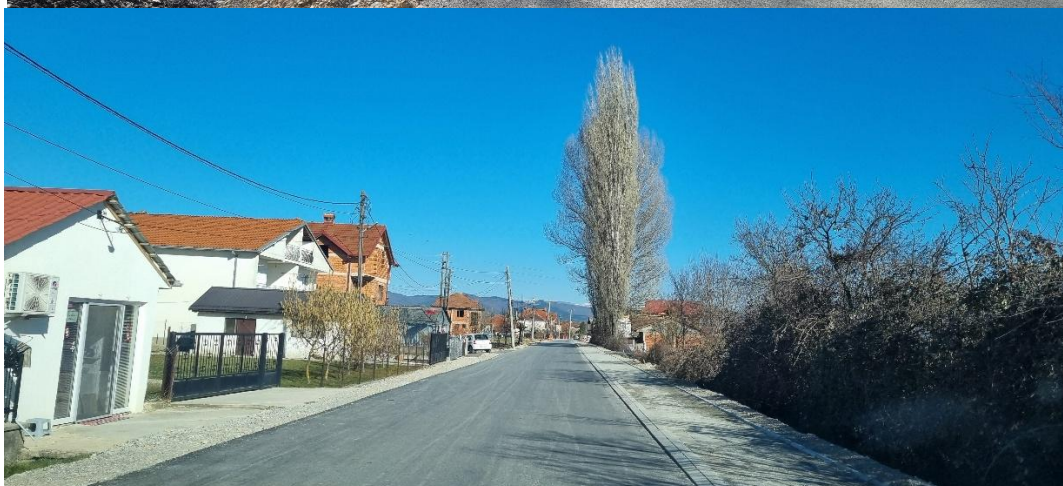
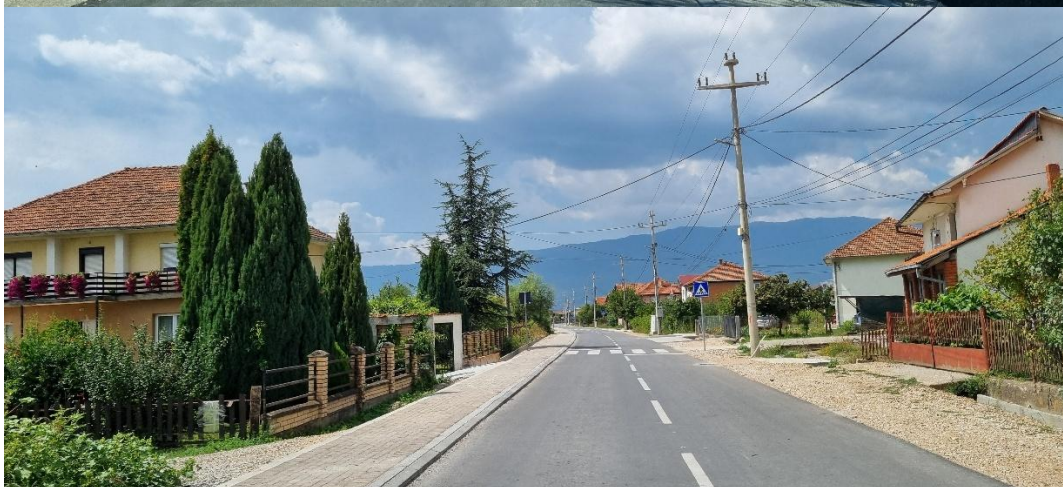
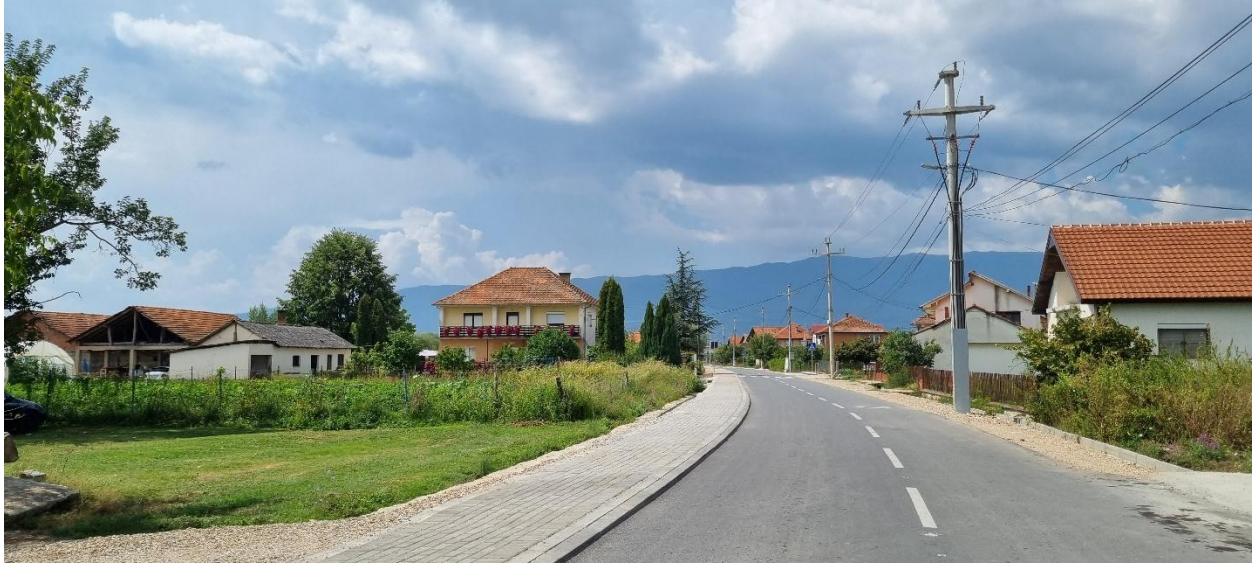
2. Images of the Road Condition After Completion of Construction Works

- **Newly paved asphalt surface** (smooth, even, and properly structured)
- **Completed pedestrian pathway** (1.3 m wide, safely separated)
- **Functional drainage system** (concrete channels and culverts)
- **Installed curbs and road edges** (reinforced with concrete, MB40 18/24)
- **Traffic signage and road markings** (clear and compliant with regulations)
- **Shoulders and buffer zones** (properly constructed with crushed aggregate)
- **Overall enhanced road safety and usability**
